NASA-DoD Lead-Free Electronics Project

April 2010

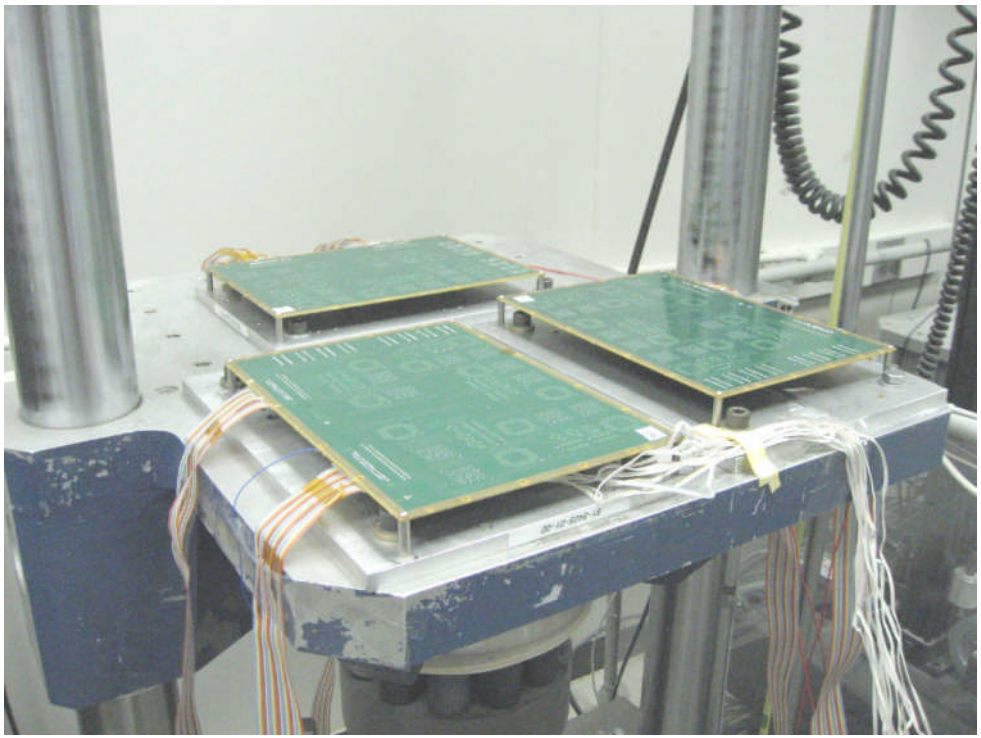
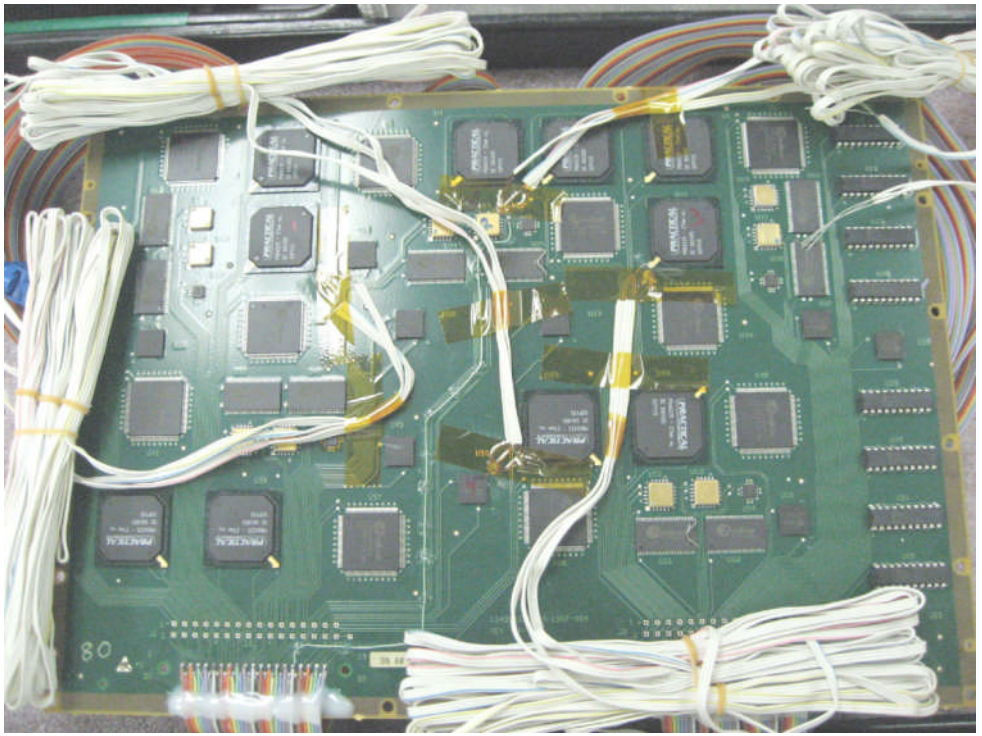
- Only component to have significant failures – BGA 225
- The 4 non-BGA samples that had an electrical failure had the following rework histories:
  - SN 85, TQFP 144, U57 was reworked once
  - SN 85, PDIP-20, U8 was reworked once
  - SN 84, CLCC-20, U14 was not reworked
  - SN 86, QFN-20, U15 was reworked twice

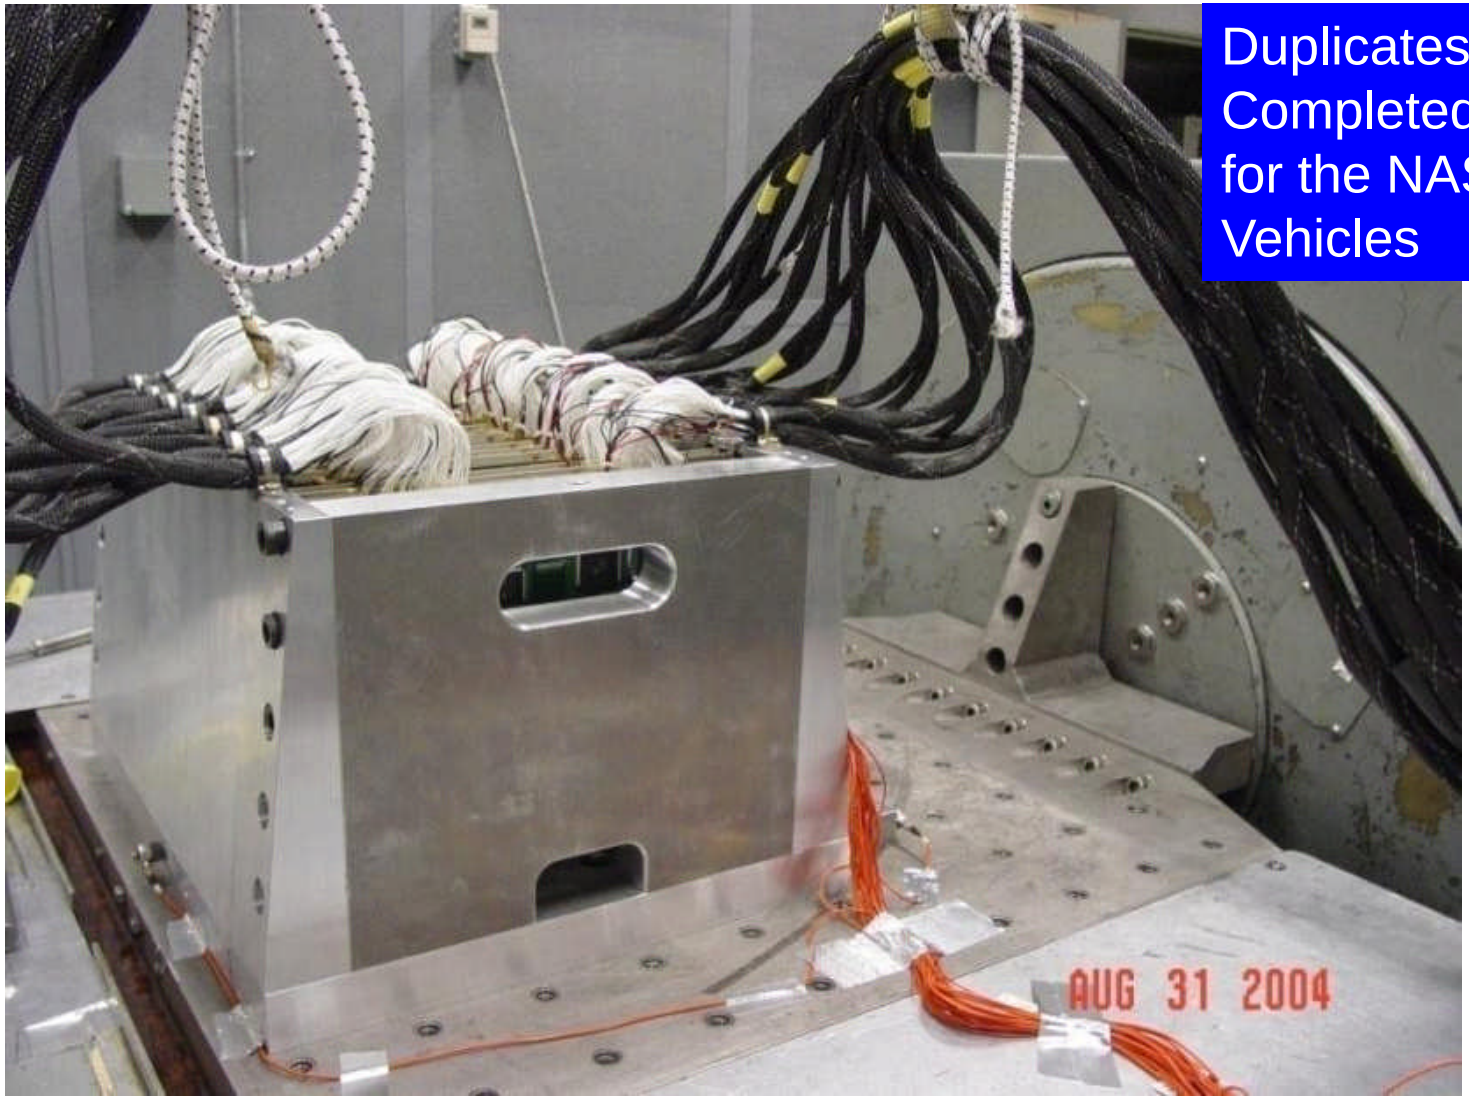
- Among the parameters tested, unexplained variation continues to dominate the results
  - Batch or Card S/N did not significantly influence the results
  - Component package style had a marked influence on both the time to failure (Tf) and on the number of cycles to 10% failure (N10)
- Rework
  - Did influence Time to failure
  - Did not significantly influence N10
- Location on the board
  - Did significantly influence Tf
  - Did not significantly influence N10

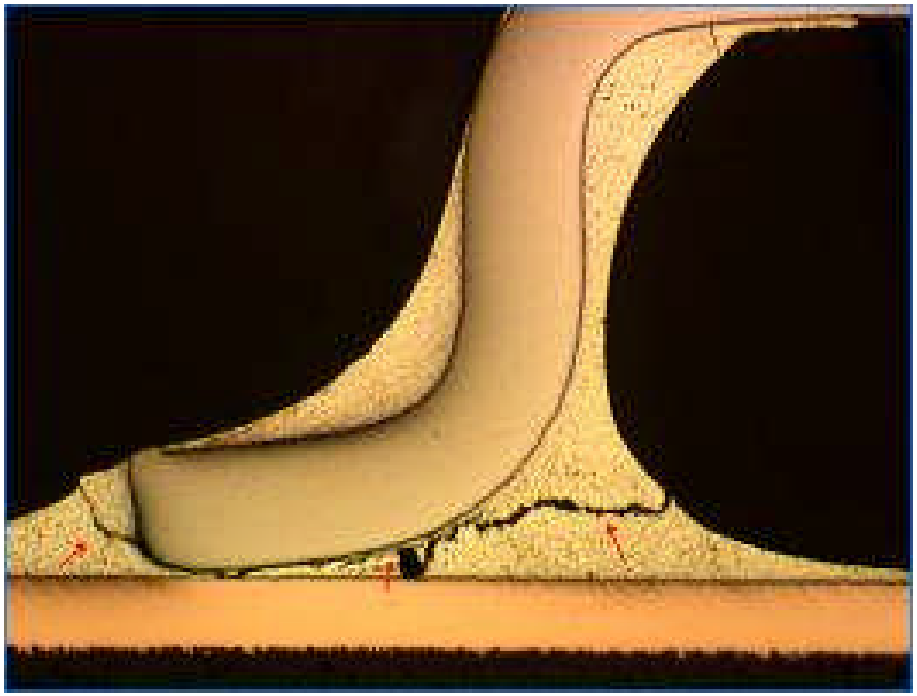
SN67, U61, left lead solder crack, 100x

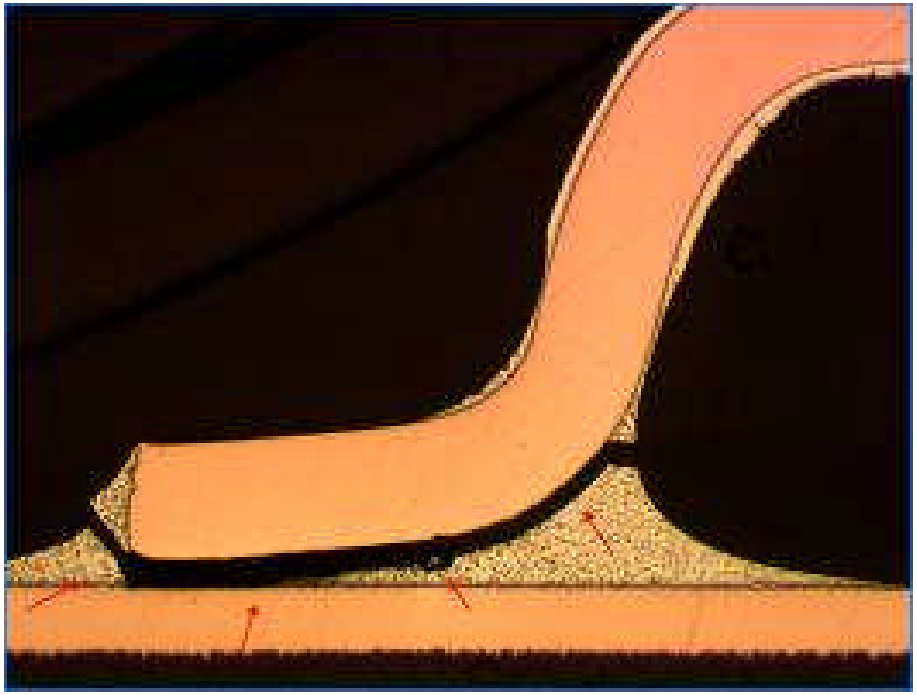
SN67, U31, left lead solder crack, 100x

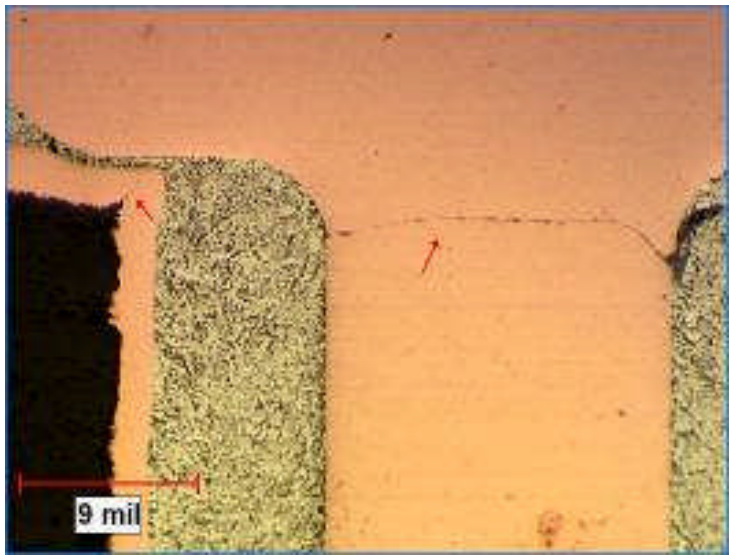
SN 79, U49, pin 11, 100x

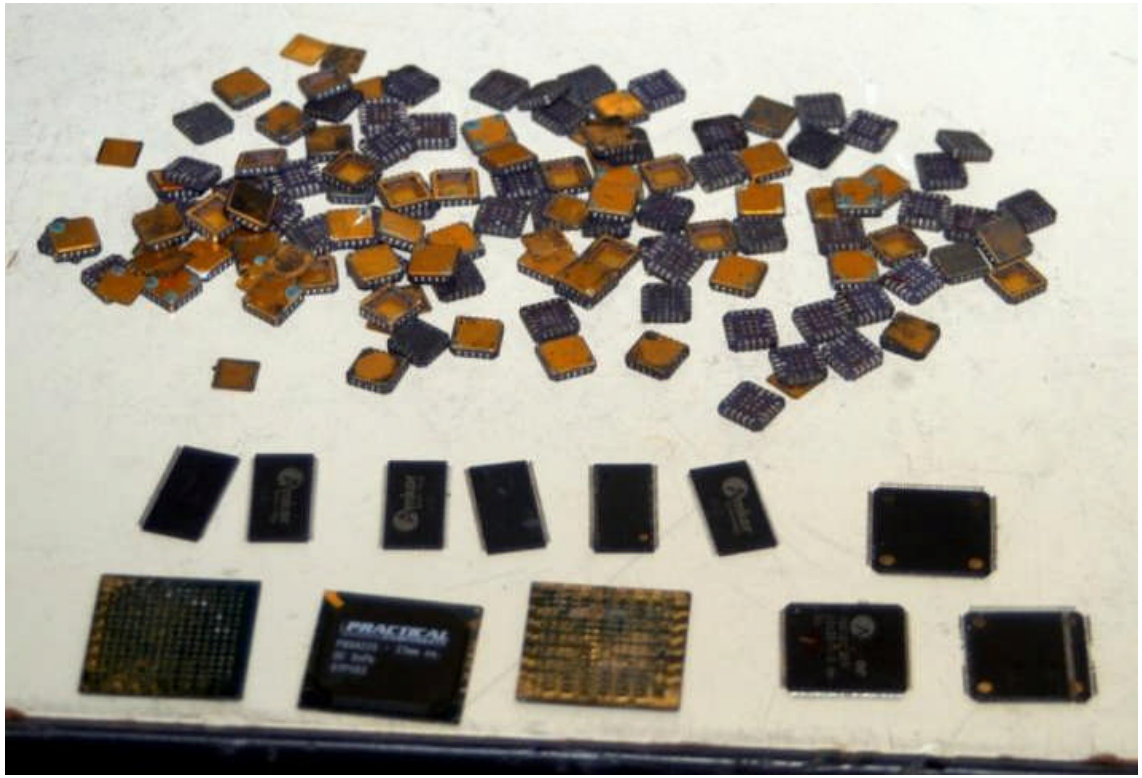
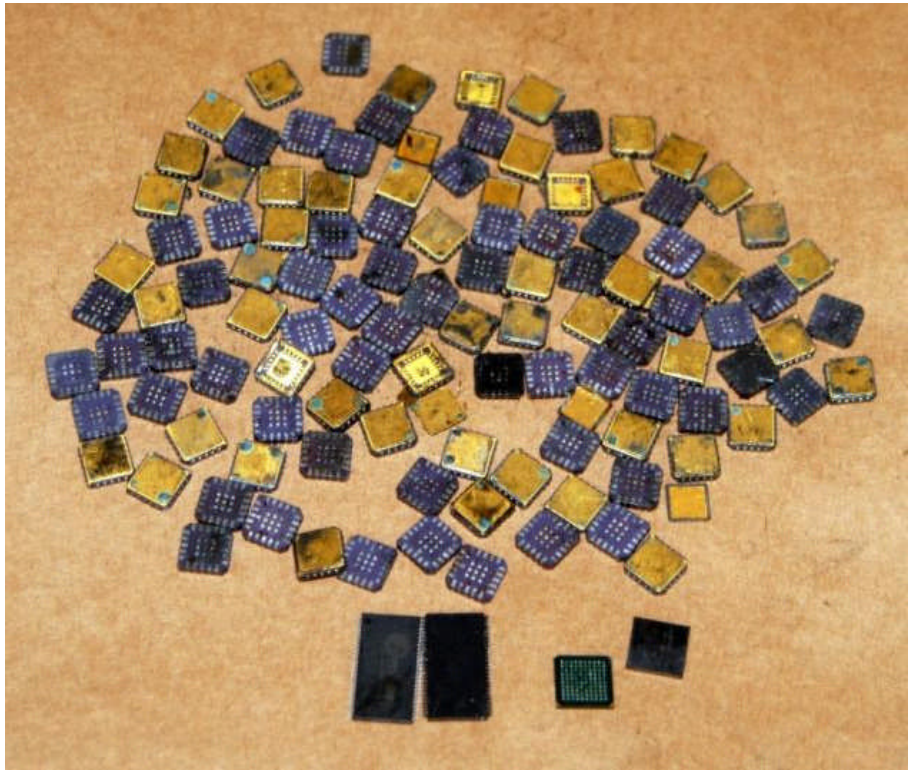
Overall, the component type had the greatest effect on solder joint reliability performance.

- The plated-through-hole components proved to be more reliable than the surface mount technology components.
- The plated-through-holes (PTH), PDIP-20, TQFP-144 and QFN-20 components per-formed the best.
- The BGA-225 components performed the worst.

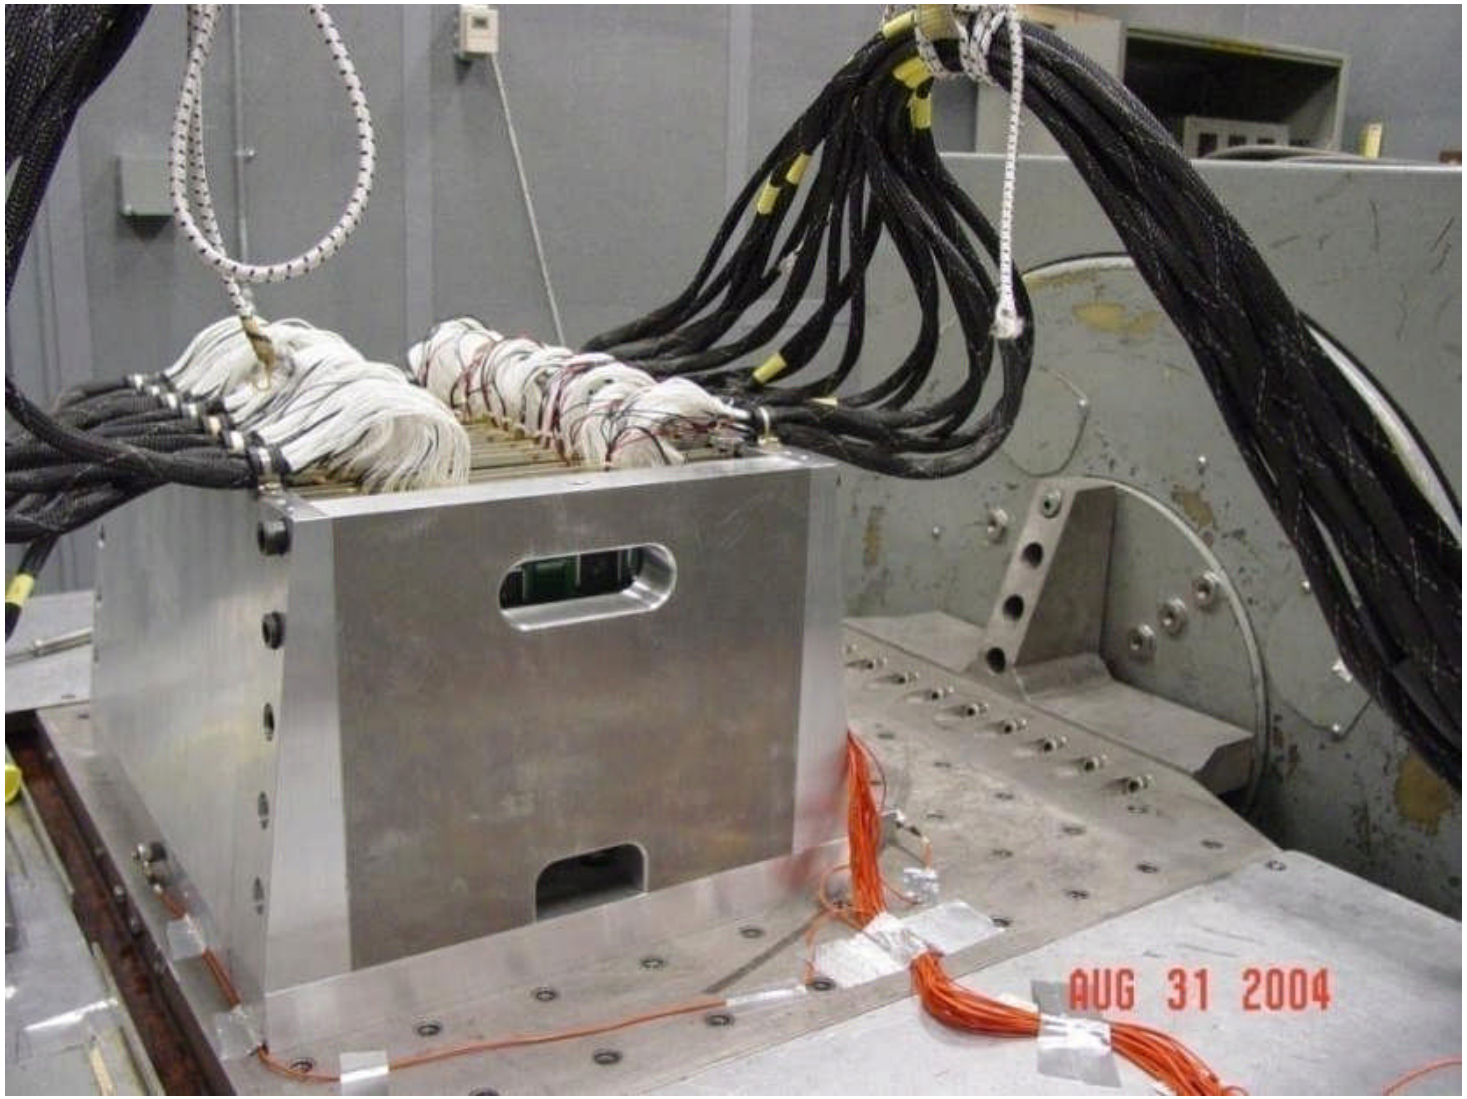
- Very early PDIP failures were observed.
- At an initial glance, the data does not look much different than the JCAA/JGPP test results.
- There does seem to be a big difference between solder alloys.

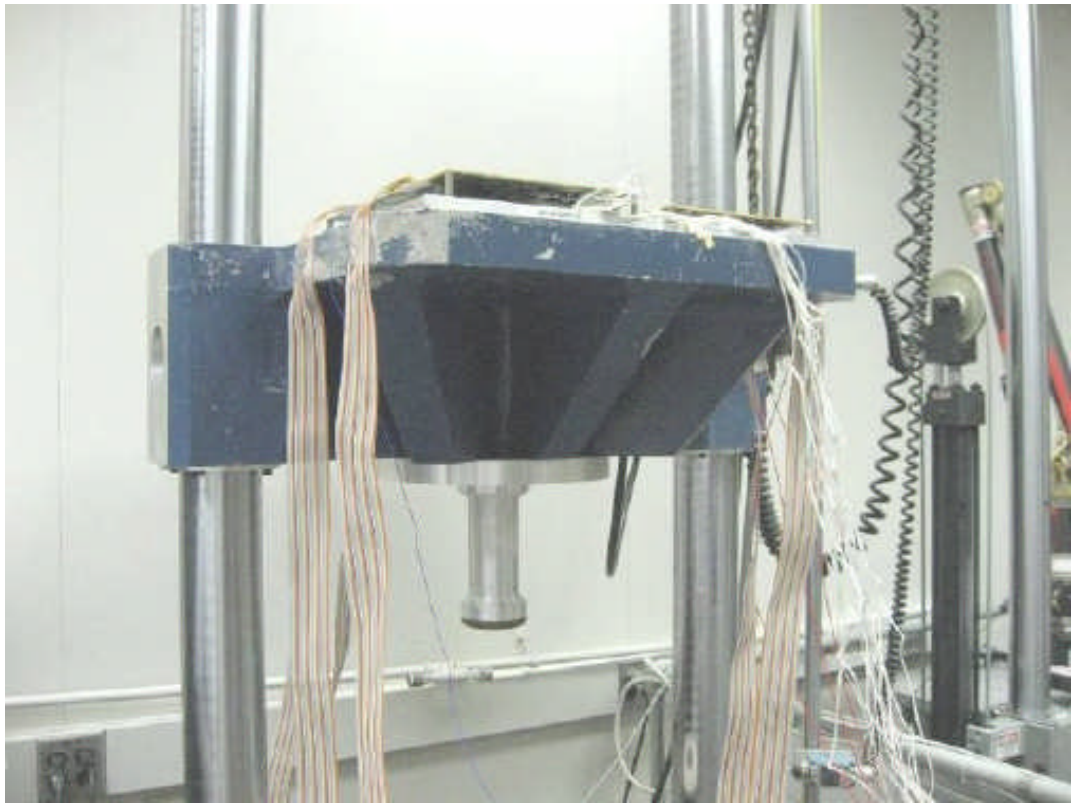
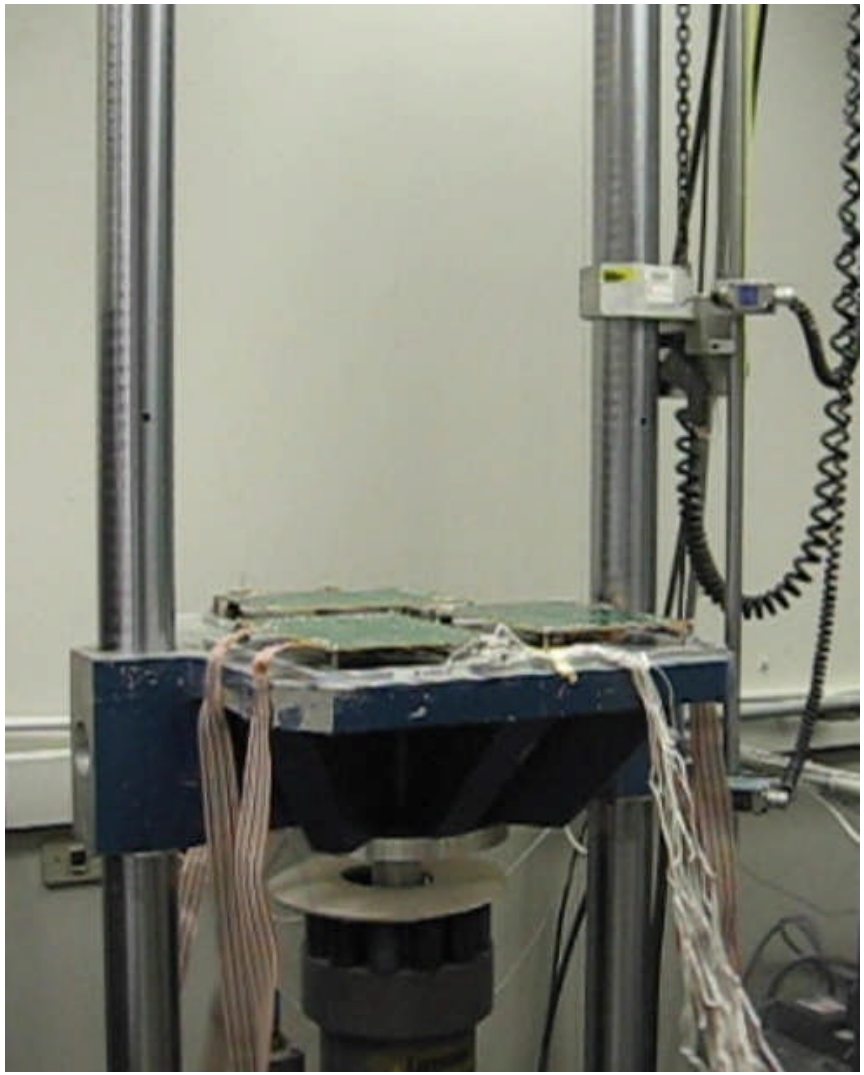
- Only component to have significant failures – BGA 225
- Most failures occurred on or near the corners.
- General ranking – Based on Raw Data – No Failure Analysis
  - Overall; Manufactured test vehicles performed better than Rework test vehicles
  - SnPb Manufactured performed better than Lead-Free Manufactured
  - SnPb Reworked performed better than Lead-Free Reworked
